Structured Annotation of Semantic Contents on Images from Earthquake Reconnaissance

C.M. Yeum¹, S. J. Dyke^{2,1}, J. Ramirez¹, T. Hacker³, S. Pujol¹, C. Sim⁴

¹ Lyles School of Civil Engineering, Purdue University, United States

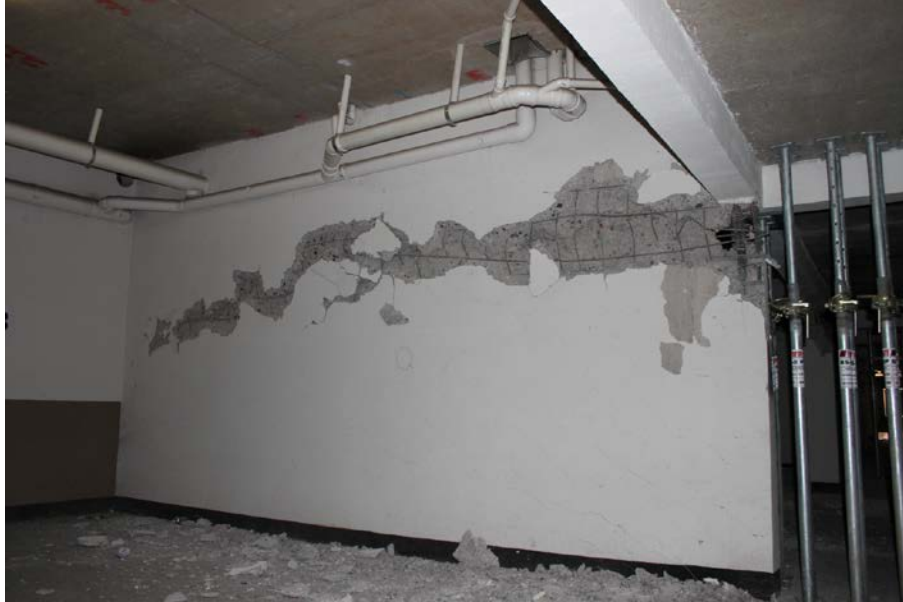
Description

“Reinforced concrete shear wall has longitudinal crushing, spalling at height of the wall, and buckling of vertical reinforcement at the boundary” (Moehle et al., 2011)

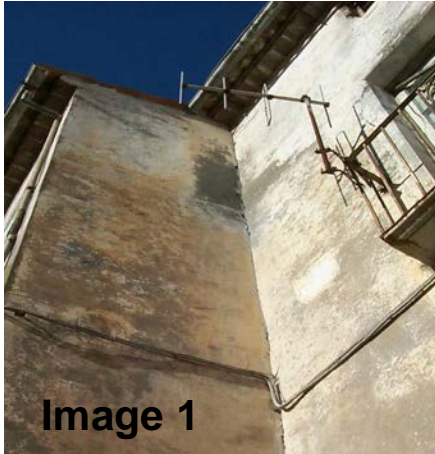
Image 1: Description: **Vertical cracks along the Orthogonal Wall** (Italy, 1998)

Statements: (F1: *Orthogonal*, T1: *Wall*, F2: *Vertical*, T2: *Cracking*)

Triples: (*Wall* – *hasDamage* – *Cracking*), (*Wall* – *hasShape* – *Orthogonal*) and (*Cracking* – *hasDirection* – *Vertical*)

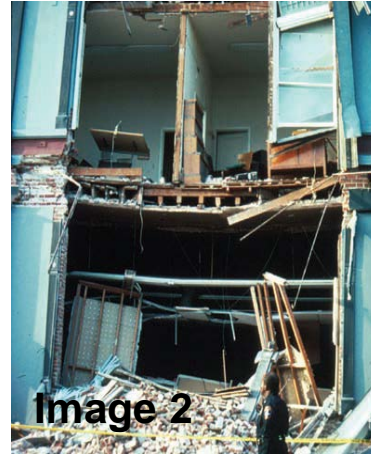
Image 2: Description: **Failure of an unreinforced masonry wall in a building** (USA, 1989)

Statements: (F1: *UnreinforcedMasonry*, T1: *Wall*, F2: *Failure*) and (T1: *Wall*, T2: *Building*)

Triples: (*Wall* – *hasMaterial* – *UnreinforcedMasonry*), (*Wall* – *hasDamage* – *Failure*) and (*Wall* – *isLocatedAt* – *Building*)

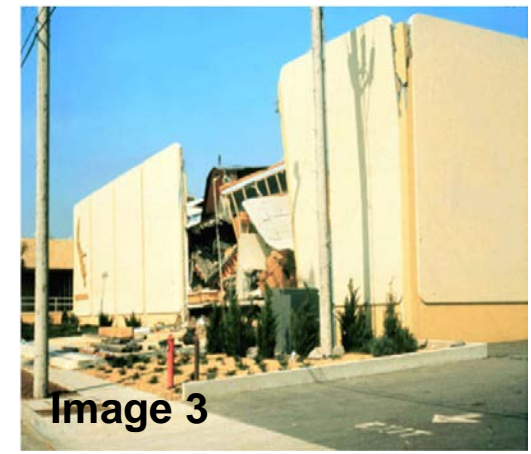
Image 3: Description: **Collapse of a tilt-up bearing wall** (1994, Northridge earthquake)

Statements: (F1: *Collapsing*, T1: *TiltWall*)

Triples: *TiltWall* – *hasDamage* – *Collapsing*

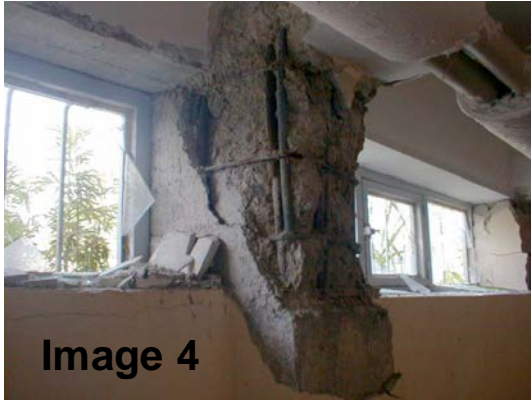
Image 4: Description: **Failed captive column in the basement** (1999, Turkey earthquake)

Statements: (F1: *Failure*, T1: *CaptiveColumn*, T2: *Basement*)

Triples: (*CaptiveColumn* – *hasDamage* – *Failure*) and (*CaptiveColumn* – *isLocatedAt* – *Basement*)

Query 3. Which damaged object is located in the basement?

Object **and** (hasDamage **some** Damage **and** isLocatedAt **some** Basement)

- ◆ Captive Column 4 ?

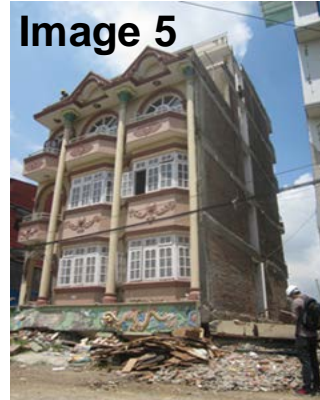
Image 5: Description: **Soft story failure** (2015, Nepal earthquake)

Statements: (F1: *SoftStory*, T1: *Building*)

Triples: *Building* – *hasDamage* – *SoftStory*

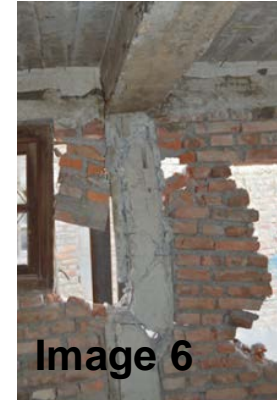
Image 6: Description: **Shear failure reinforced concrete column next to collapsed masonry wall** (2015, Nepal earthquake)

Statements: (F1: *ShearFailure*, T1: *Column*, F2: *Collapsing*, T2: *Wall*) and (F1: *ReinforcedConcrete*, T1: *Column*, F2: *Masonry*, T2: *Wall*)

Triples: (*Column* – *isLocatedNext* – *Wall*), (*Column* – *hasDamage* – *ShearFailure*), (*Wall* – *hasDamage* – *Collapsing*), (*Column* – *hasMaterial* – *ReinforcedConcrete*) and (*Wall* – *hasMaterial* – *Masonry*)

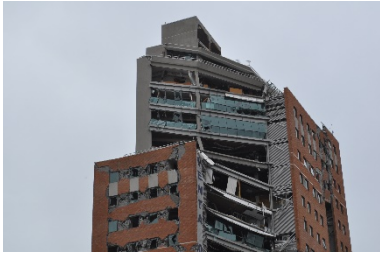
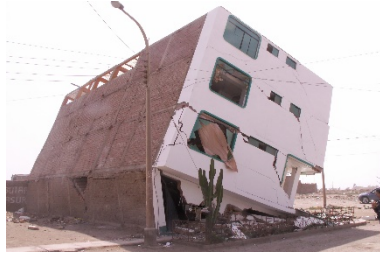
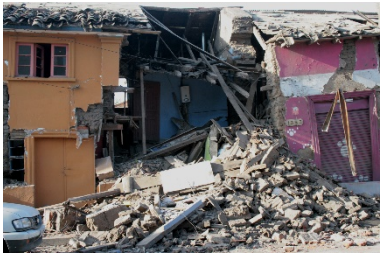
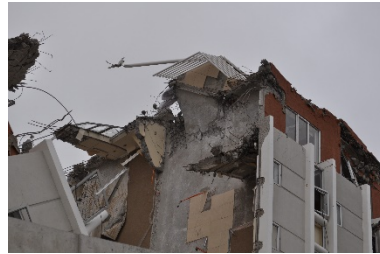
Collapse

Image showing that the buildings or building components

- lost their original shapes
- produce a large amount of debris
- are not serviceable or accessible

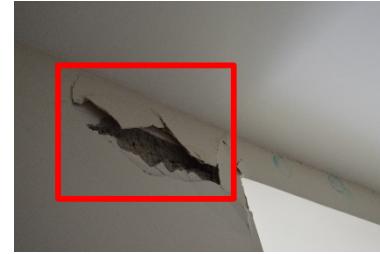
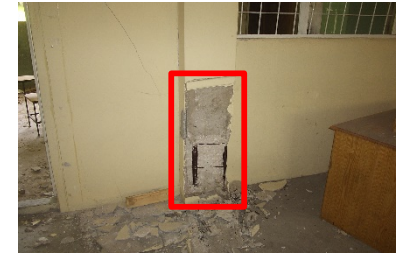
Spalling

Image including

- exposed masonry areas in a wall due to cracking followed by flaking
- exposed rebar in a columns
- small section lose due to large cracking in a concrete wall

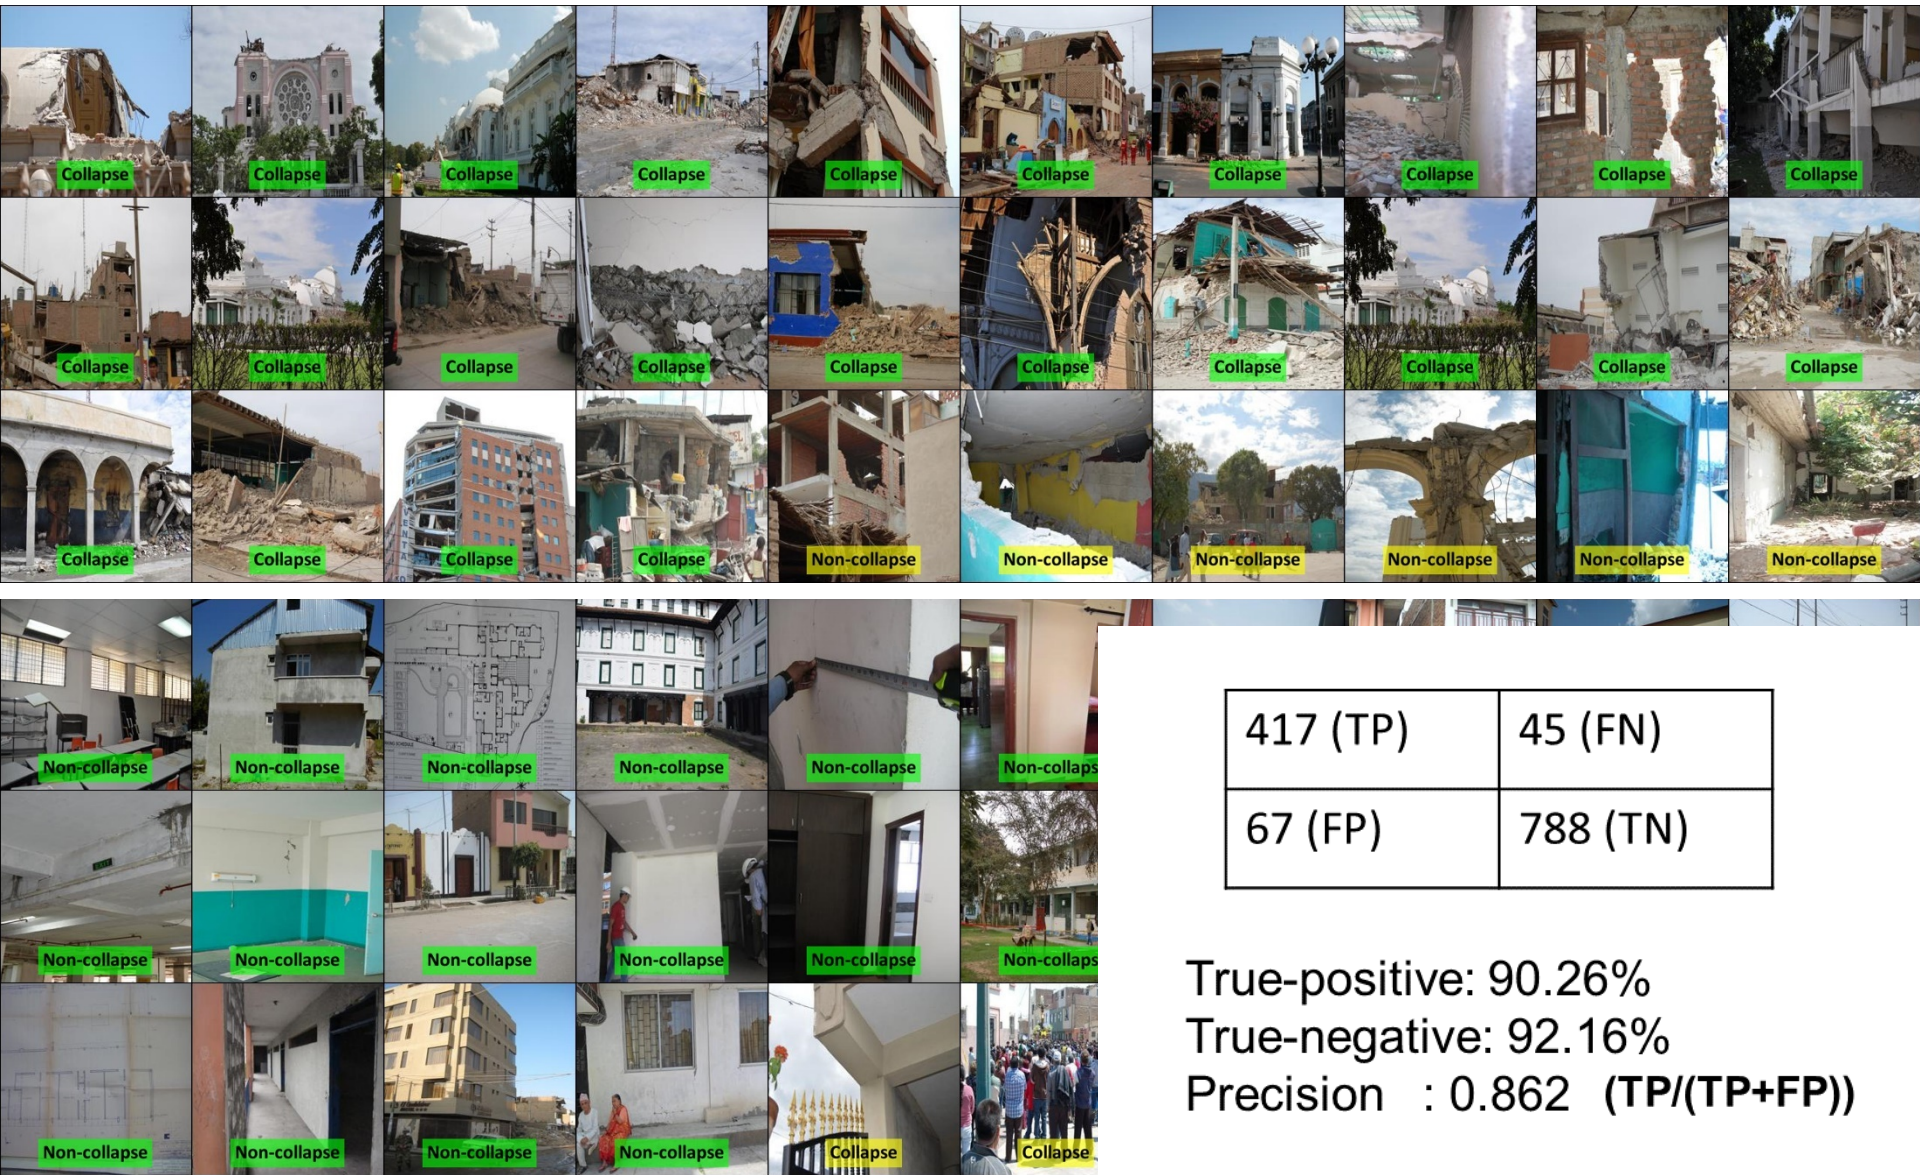
Samples of Images with the Predicted Classes

417 (TP)	45 (FN)
67 (FP)	788 (TN)

True-positive: 90.26%
 True-negative: 92.16%
 Precision : 0.862 (TP/(TP+FP))

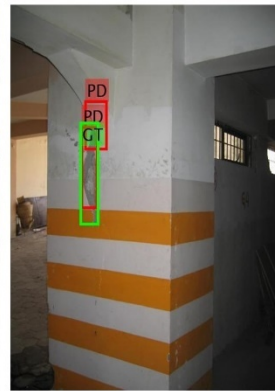
Samples of Spalling Detection

Object proposals

59.39% of true-positive (9,772/16,454 object proposals)

1.7% of false-negative (11,965/687,860 object proposals)

Final detection

40.48% of true-positive (619/1529)

62.16% of detection rate (506/814)
